by Larry Frash

## Familiar Failures and Faithful Fixes for the Mazda FN4A-EL and Ford 4F27E

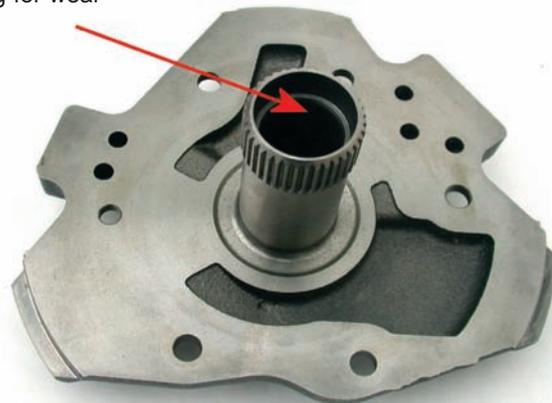
Figure 1

When the stator support bushings are worn, they can allow converter apply pressure to leak into the release side of the converter. When this occurs,

Always check this bushing for wear

Worn stator support bushings allow converter apply pressure to cross leak into the release circuit causing lockup slippage

converter release pressure can't exhaust fast enough, so it keeps pressure on the release side of the converter clutch. This prevents the converter clutch from fully applying, which causes the converter clutch to slip.

To avoid this problem, always check for wear between the stator support bushings and turbine shaft, whenever you're rebuilding one of these transmissions. If you find more than 0.0015" clearance, replace the bushings. These bushings are made by Omega Machine & Tool, Inc. and are available from a number of sources in the aftermarket.

Once you've replaced the bushings, slide the stator shaft into place and recheck the clearance between the shaft and the bushings; while not particularly common, it is possible for the shaft itself to wear and need replacement.

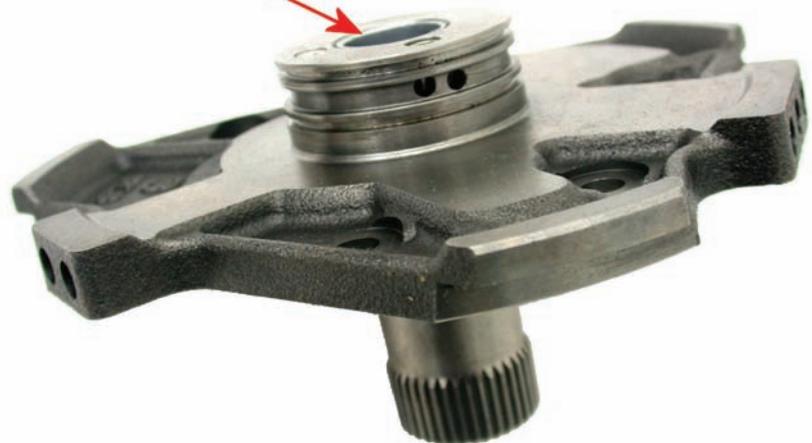
Figure 2

Always check this bushing for wear

Worn stator support bushings allow converter apply pressure to cross leak into the release circuit causing lockup slippage

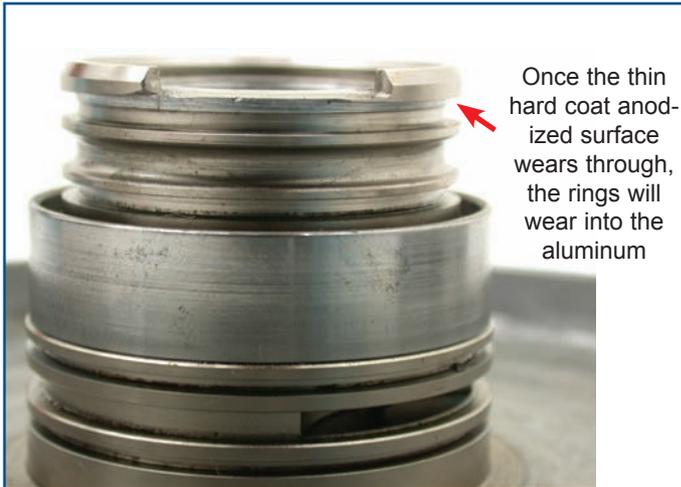
Figure 3

It's not uncommon to see wear in the end cover, around the top direct

clutch ring land area (figure 3). On Mazda applications, the end cover is aluminum and is hard coat anodized around the ring land area (figure 4). This hard coating is designed to prevent the rings from wearing into the soft aluminum. Once the thin anodized coating wears through, the ring wears into the bare aluminum, destroying the cover.

So, to avoid wear in the end cover, you should always use the Ford cover. Whenever you rebuild an FN4A-

EL/4F27E transmission, check the end cover carefully to see which one is being used. Never reuse the hard coat anodized cover, even if there's no sign of wear in the ring area. Always replace the Mazda-style end cover with a Ford cover, part# XS4Z-7222-BA. This cover will work on all models, with a few minor modifications:

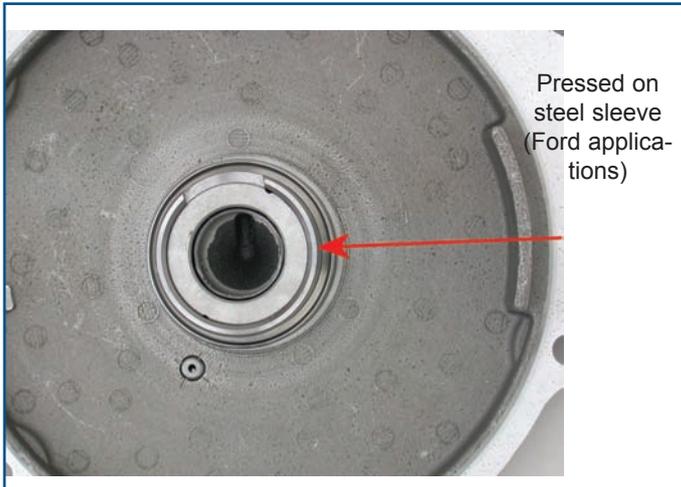
Figure 5

The end cover used in Ford applications is also made out of aluminum, but this cover has a pressed steel sleeve for the ring land area (figure 5). And, since the direct clutch rings ride against the steel surface, ring land wear isn't a problem on Fords.

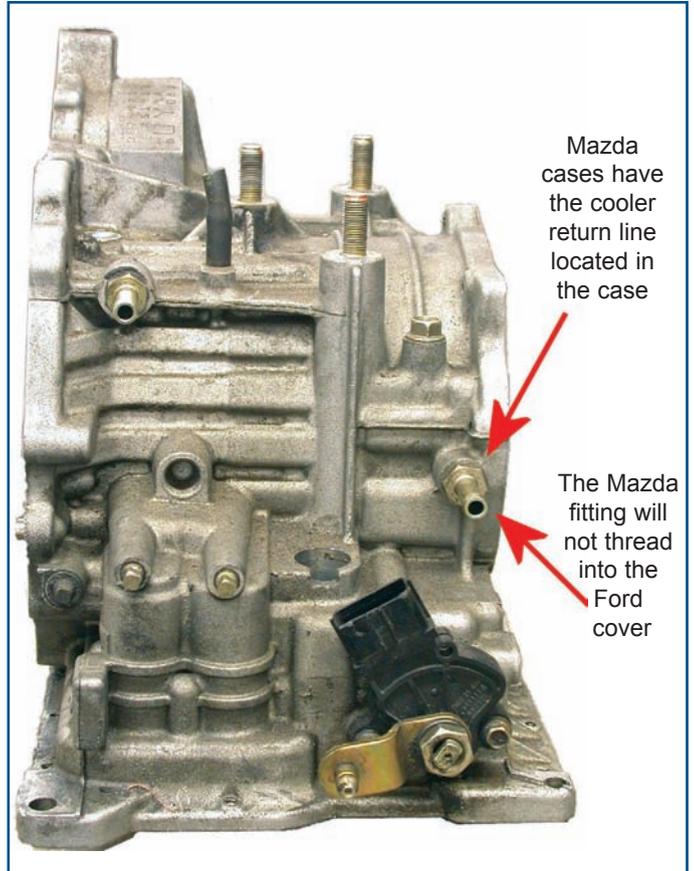
Figure 6

The Mazda version of the FN4A-EL/4F27E transmission has the cooler return line located in the case (figure 6). From there it's routed through a passage to the end cover to provide

To adapt the Ford cover for use with a Mazda transmission, you must reroute the cooler return circuit. Here's how:

Remove the original cooler line fitting from the Mazda case to use it as a template to make a new fitting. The threads are different and won't fit the Ford end cover. When you order the Ford end cover, also order a 3/8" fitting adaptor from Ford, part# YS4Z-7D273-AA. Install it into the Ford end cover.

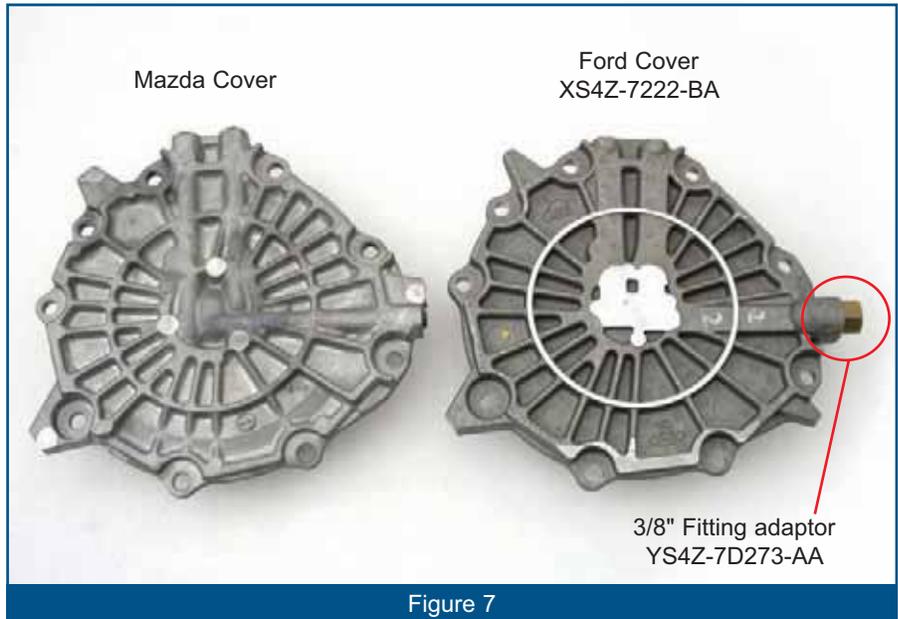
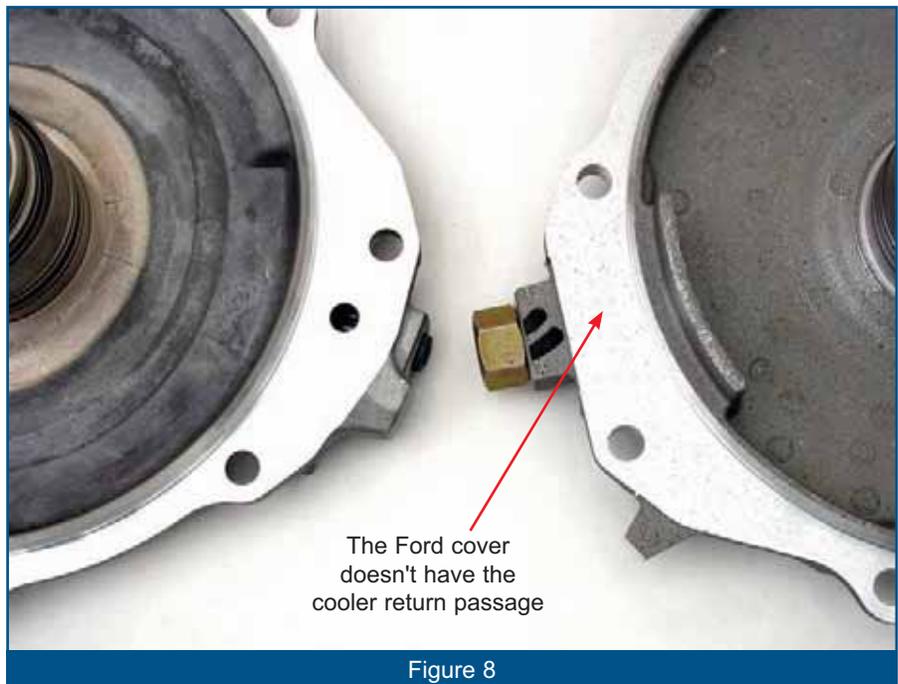
lube oil to the transmission. The Ford version of this transmission has the cooler return line threaded directly into the end cover. Because of this, the Ford end cover doesn't have the cooler return passage from the case that the Mazda cover has (figure 7 and 8).

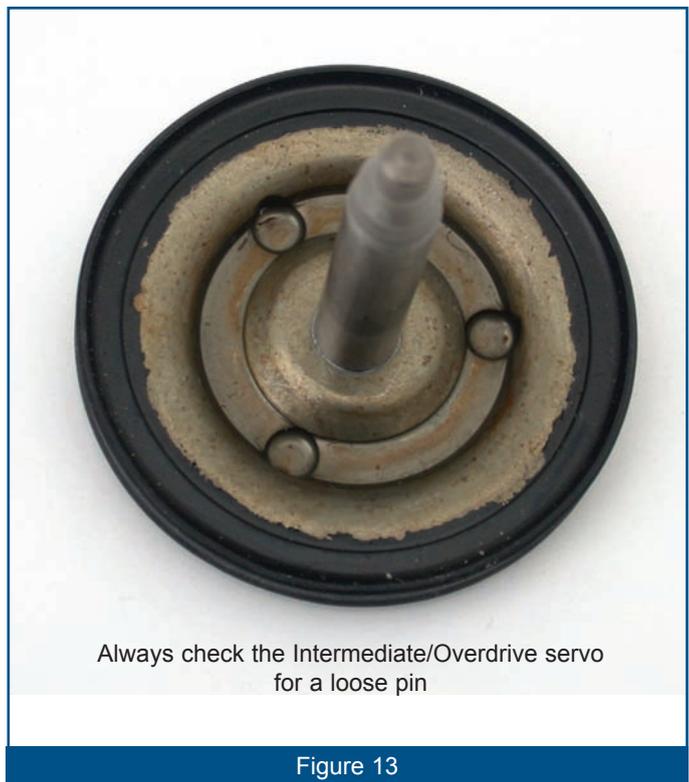
Figure 13

The intermediate/overdrive band servo is a molded rubber piston with a pressed-in pin (figure 13). Problems occur when the pin becomes loose in the piston and causes leaks between the apply side and the release side of the servo. Symptoms of a loose pin can include:

- Ratio errors
- 2<sup>nd</sup> gear slip
- 2-3 flare
- 3<sup>rd</sup> gear slip

But the most common symptoms caused by a loose servo pin are a slip in 4<sup>th</sup> gear and 4<sup>th</sup> gear ratio codes. If the pin gets loose enough, it will come completely out of the piston, causing major problems (figure 14). To avoid problems from this servo, always replace the servo with a new one during every rebuild.

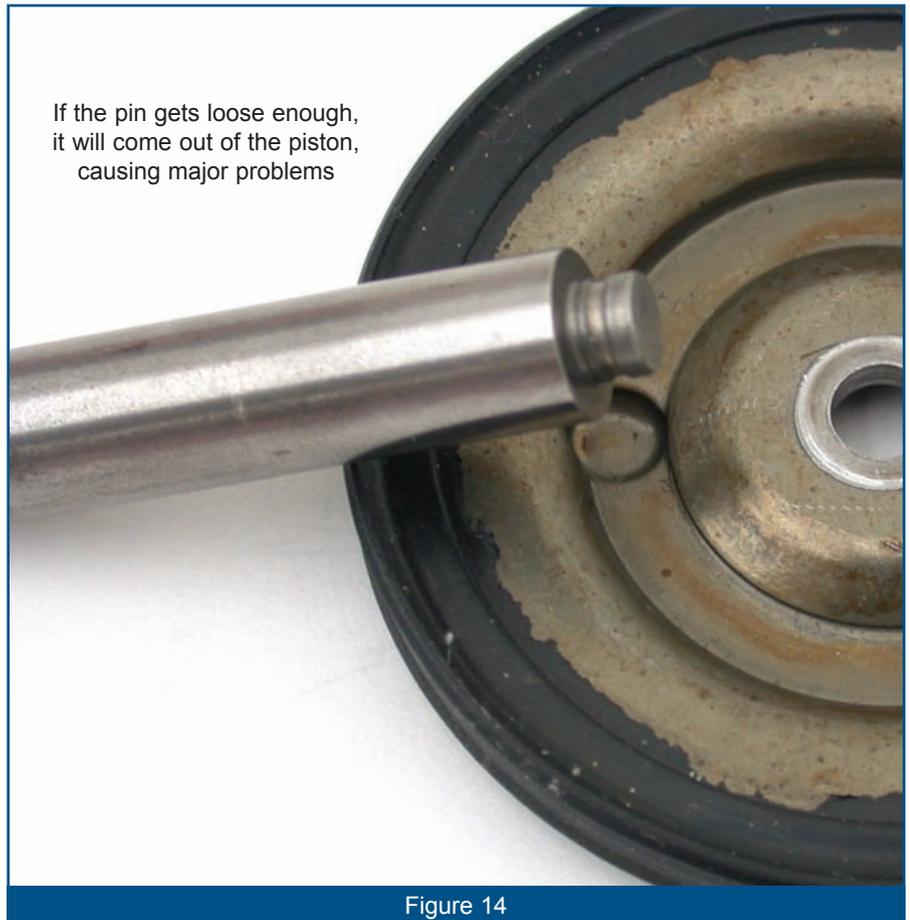
Figure 14

If the pin gets loose enough, it will come out of the piston, causing major problems
